FINAL REPORT  
RICHARDSON FLATS TAILINGS  
SUMMIT COUNTY, UTAH  
TDD #T08-9204-015 and #T08-9210-050  
PAN EUT0039SBA and EUT0039SDA

U.S. Environmental Protection Agency  
Region VIII  
Waste Management Division  
Mike Zimmerman, On-Scene Coordinator

Scott Keen  
Ecology and Environment, Inc.  
Technical Assistance Team

FINAL REPORT  
RICHARDSON FLATS TAILINGS SITE  
TDD #T08-9204-015 and #T08-9210-050  
PAN EUT0039SBA and EUT0039SDA

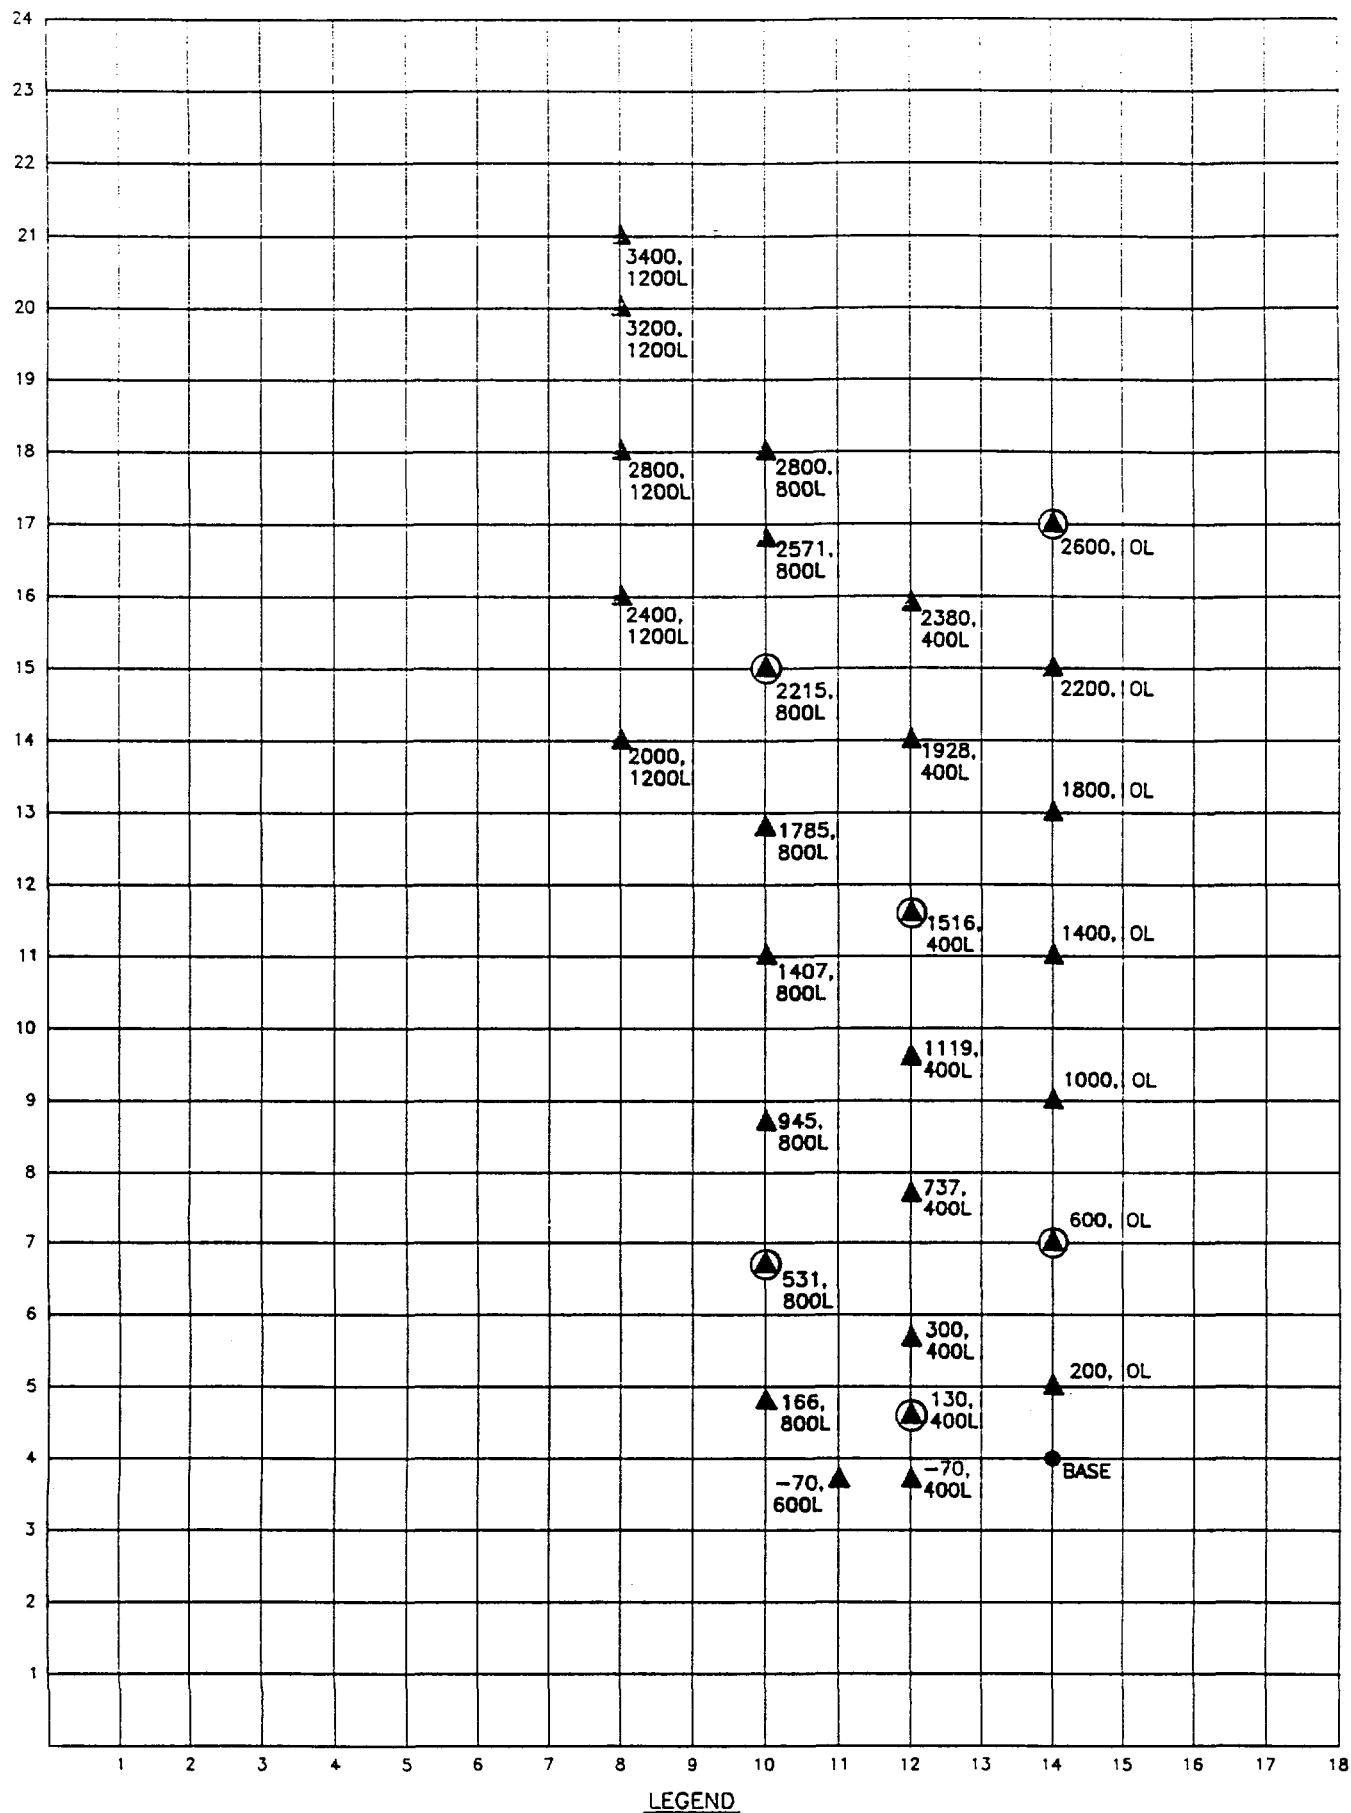
**Figure 2**  
**RICHARDSON FLATS**  
**August 4, 5, 6, 1992**

Depth of cover was determined at 29 locations over the tailings area. These locations are depicted on Figure 2. Locations were determined by first establishing a reference line in an approximate direction of northwest to southeast through the tailings area (Figure 1). This reference line includes and is a continuation of a straight portion of the tailings containment structure as shown in Figure 1. Points were marked along this reference line at 200 or 400 foot intervals. At 2800 feet from the base point a second reference line was established in a perpendicular direction to the first reference line. This second reference line extended in an approximate direction from southwest to northeast. For the purpose of sampling or soil cover measurements, all locations within the tailings area were identified relative to these two reference lines. For example, a sample location identified as 1900, 800L would be 1900 feet from the base point (using the first reference line) and 800 feet to the left (northeast) using the second reference line.

The grid pattern shown in Figure 2 represent much of the entire tailings area. Of the 29 points on this grid only 1 point had no cover soil and no salt grass present. Nine of the 29 points (approximately 30 percent) had no cover soil present. At the 20 points where cover soil was present, the cover soil was 6 inches thick or less at 6 points and greater than 6 inches in thickness at 14 points.

Figure 2 shows the location of six soil samples collected on August 6, 1992. Each of these samples, except sample RF-SO-3, was taken from soil that was added by UPCM as cover to the site. Table 2 contains analytical results for these samples and the normal ranges for these elements in soils of the western United States. Sample RF-SO-3 was collected within an area covered by salt grass. As discussed, where salt grass is currently established soil cover has not been added by UPCM. This soil sample is more likely to be representative of tailings material.

UPCM has expressed intentions of adding soil cover to that small portion of the site which currently has no soil cover or where salt grass is not established. When this is completed, the tailings area will have adequate cover to prevent an immediate threat of excessive dust. Much of the existing soil cover, however, is sparse (less than six inches in thickness); and much of the area is covered with a salt grass that may disappear as the site becomes drier. Dusty conditions could recur in the future if proper soil cover over the entire tailings area is not applied.

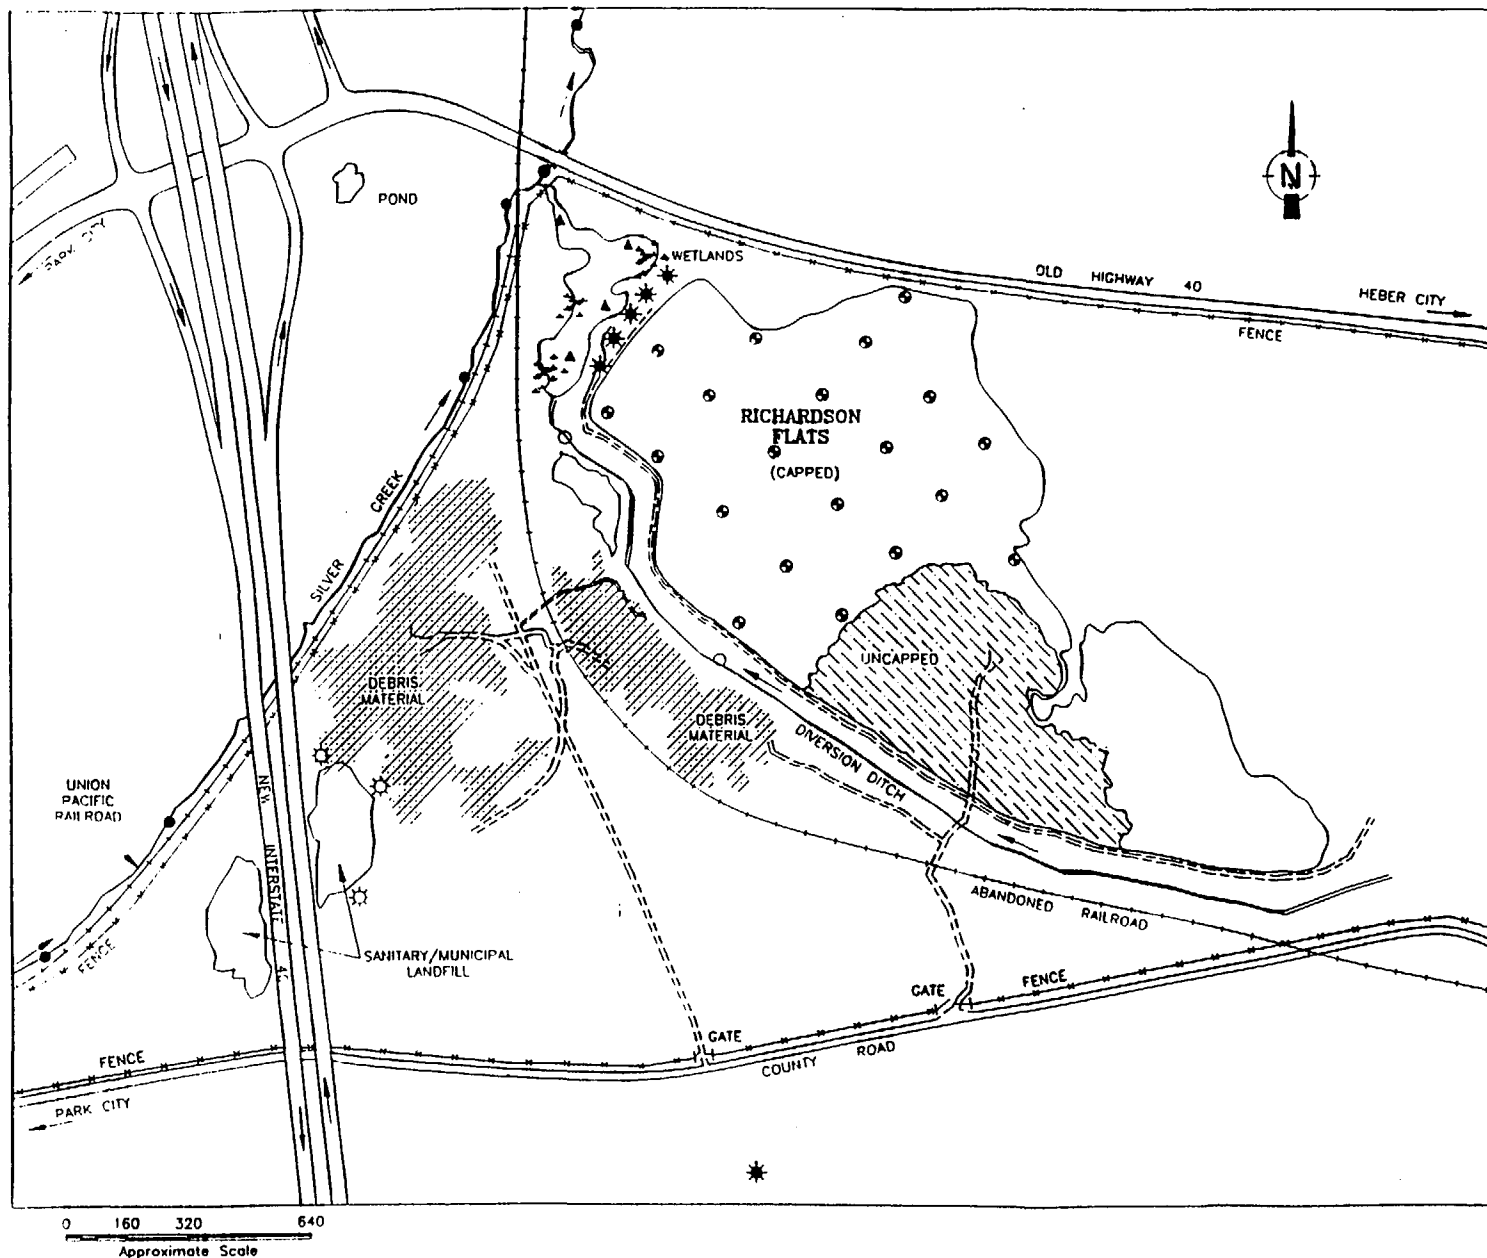
FIG. 1

Surface water samples collected for assessment of the tailings area are shown on Figure 1. These eight sample numbers are RF-SW-01 through RF-SW-08. Inorganic analytical results for surface water samples are presented in Table 3. Within Silver Creek samples RF-SW-01 through RF-SW-04 are considered upgradient of the tailings area and samples RF-SW-05 and RF-SW-06 are downgradient. In comparing upgradient sample results with downgradient sample results very few significant differences are noted. Lead increases by a factor of 5.7 in sample RF-SW-05 when compared to the average lead concentration of the four upgradient samples. In sample RF-SW-06 arsenic increases by a factor of 2.1 and silver increases by a factor of 4.2 when compared to the average concentration of the four upgradient samples.

One upgradient and two downgradient monitoring wells (Figure 1) were sampled during the week of August 4, 1992. Results of inorganic analyses are presented in Table 6. Sample RF-GW-04 is from the upgradient well; samples RF-GW-05 and RF-GW-09 are from two wells at the base of the tailings dam.

Figure 1 shows a "wetlands" area between the base of the tailings dam and Silver Creek. Within this area four sediment samples were collected. Results of inorganic analyses of these samples is presented in Table 7 along with the normal ranges of elemental concentrations in soils of the western United States.

As shown in Figure 1, the three monitoring wells (1, 2 and 3) in the area of the municipal/sanitary landfill roughly surround the landfill. Analytical results confirm that sample location RF-MW-01 is hydraulically upgradient to sample locations RF-MW-02 and RF-MW-03. Estimates of total dissolved solids (TDS) for this upgradient monitoring well show that upgradient groundwater TDS is well below 500 ppm. Based on the inorganic analytical results of Table 8 and a TDS value of less than 500 ppm, groundwater immediately upgradient of the landfill is classified as Class 1A, Pristine Groundwater, by the State of Utah Groundwater Quality Standards.

Of the six surface water sample locations shown in Figure 1, two locations (RF-SW-01 and RF-SW-02) were upgradient of the landfill; the other locations were downgradient. Comparison between upgradient and the two closest downgradient samples (RF-SW-03 and RF-SW-04) of inorganic data (Table 3) show no significant increases in contaminant concentrations as Silver Creek flows past the landfill.
